Cover-Collapse Sinkhole Development in the Cretaceous Edwards Limestone, Central Texas

Originally published in the 13th Sinkhole Conference

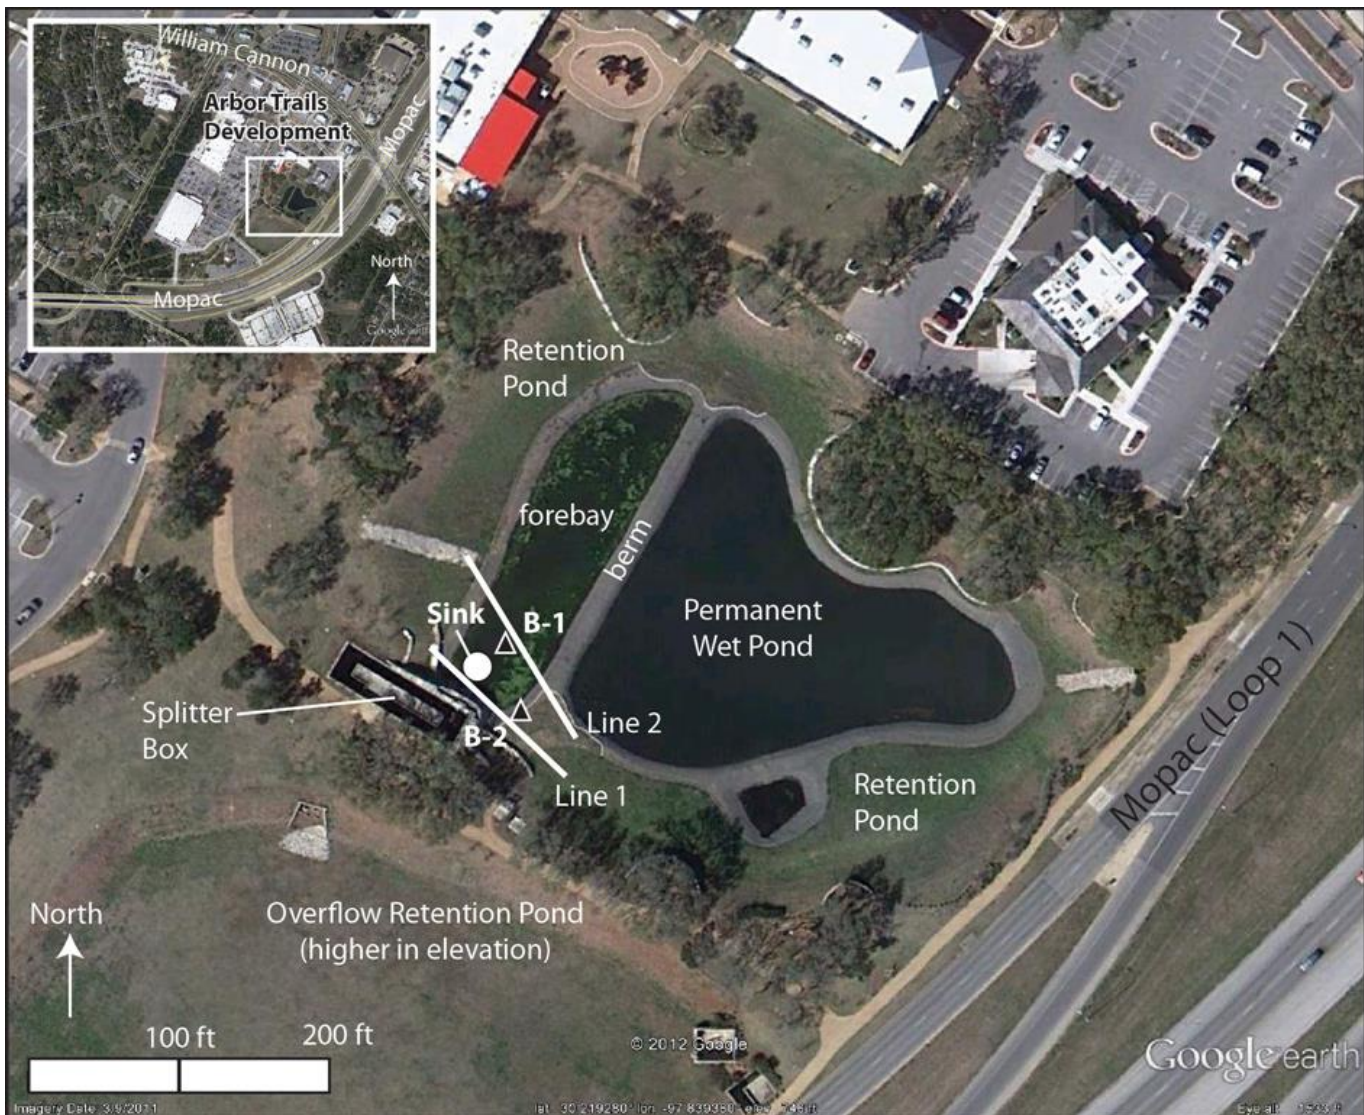
Figure 3. Detailed site map with key elements of the stormwater retention pond (SWRP), sinkhole location, and 2012 geophysical lines and boreholes.

The location of the SWRP for the Arbor Trails development is shown in Figure 3. The purpose of the SWRP is to capture storm runoff from impervious areas (buildings and parking lots) and then irrigate vegetative areas with the stormwater throughout the property. The SWRP consists of two

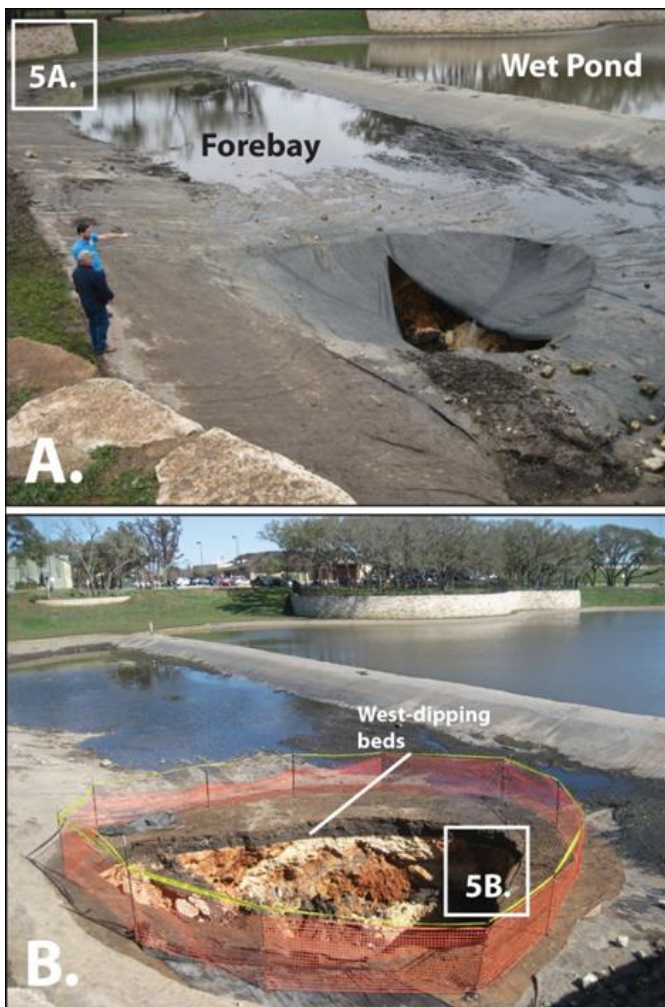
Figure 4. Photograph of sinkhole, all photos facing north. A) photo taken the day the sinkhole was observed (credit Heather Beatty, TCEQ). B) Photo taken two days after collapse and prior to excavation. Note the limestone beds are dipping to the west.

On January 24, 2012 a 11 cm (4.5 in) rainfall event occurred in the area of the Arbor Trails development filling the SWRP with about 3 m (10 ft) of water (Figure 4). On January 25, 2012 maintenance crews noticed the pond was draining, and that a sinkhole had developed (Figure 5). The size of the sinkhole was about 9 m (30 ft) in diameter and 4 m (12 ft) deep. About 26.5 million liters (7 million gallons) of storm water drained into the aquifer through this opening.

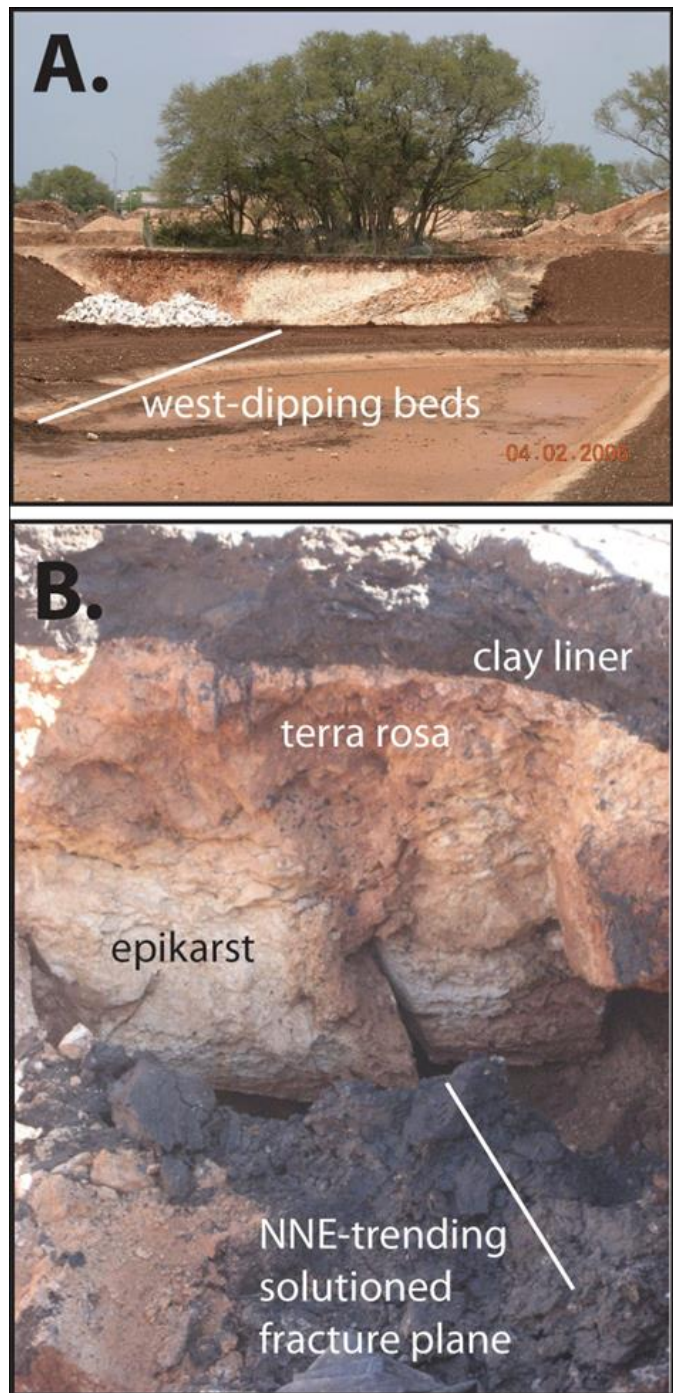
Figure 5. Photograph locations indicated in Figure 4. A) Photo during construction of SWRP showing west-dipping beds in the northern wall of the forebay (photo credit Andrew Backus, 4/2/2006); B) Photo of the northern wall of the sinkhole taken two days after collapse and prior to excavation.

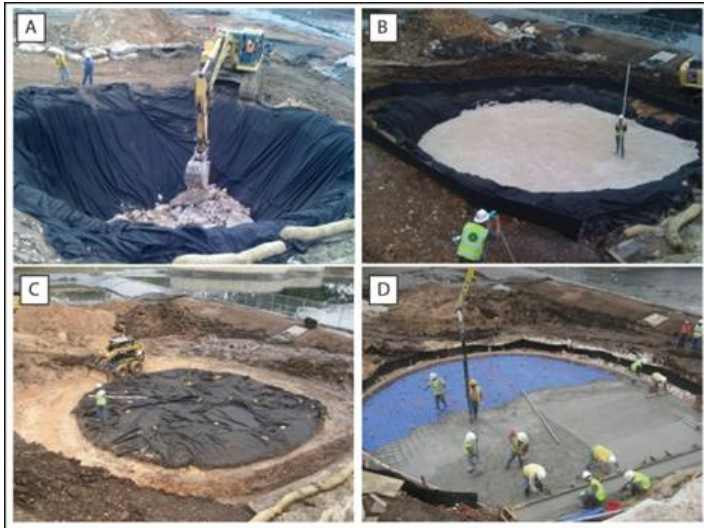
Figure 10. Photographs during sinkhole mitigation. A) Boulders and coarse fill and filter fabric; 5/2/12, B) graded cobble to gravel fill; 5/7/12, C) Gravel-filled sinkhole and filter fabric; 5/9/12, D) Reinforced concrete cap and blue vapor barrier; 5/10/12.

An engineered closure design by Bury + Partners (Austin, Texas) was reviewed and approved by the City and State to mitigate the sinkhole. The plan consisted of graded fill interlayered with filter fabric (Figure 10). Large rock (> 15 cm, >6 inch) filled the base and was overlain by 7-12 cm (3-5 in) gravel, then overlain by 3-8 cm (1-3 in) gravel, and capped with 3 cm (1 in) gravel. A vapor barrier lined the top of the gravel and a reinforced concrete slab was poured on the top and anchored into the splitter box. A compacted clay liner was installed over the concrete followed by a geomembrane liner, both of which covered the entire SWRP (Figure 11).

The sinkhole was mitigated with graded fill, geomembranes, and a concrete slab. Improvements to the SWRP included extending the liner above the high-water elevation (Figures 11 and 12D). Under the current development process it is unlikely that the regulators or developers of the area in which the sinkhole occurred would have recognized the risk associated with the location of the SWRP, or predicted the failure. Only after compiling all the information does it become clear that human activities (placement of the SWRP on the sinkhole) activated the sinkhole collapse. Part of the challenge is that the land development process in the karstic Edwards Aquifer has inherent problems of communication between geologists, engineers, consultants, and owners over the life of a project. For example, sites are fully designed and engineered,
