Dye tracing recharge features under high-flow conditions, Onion Creek, Barton Springs Segment of the Edwards aquifer, Hays County, Texas

Brian B. Hunt¹, Brian A. Smith¹,
Stefani Campbell², Joseph Beery¹, Nico Hauwert³,
and David Johns³

¹ Barton Springs/Edwards Aquifer Conservation District

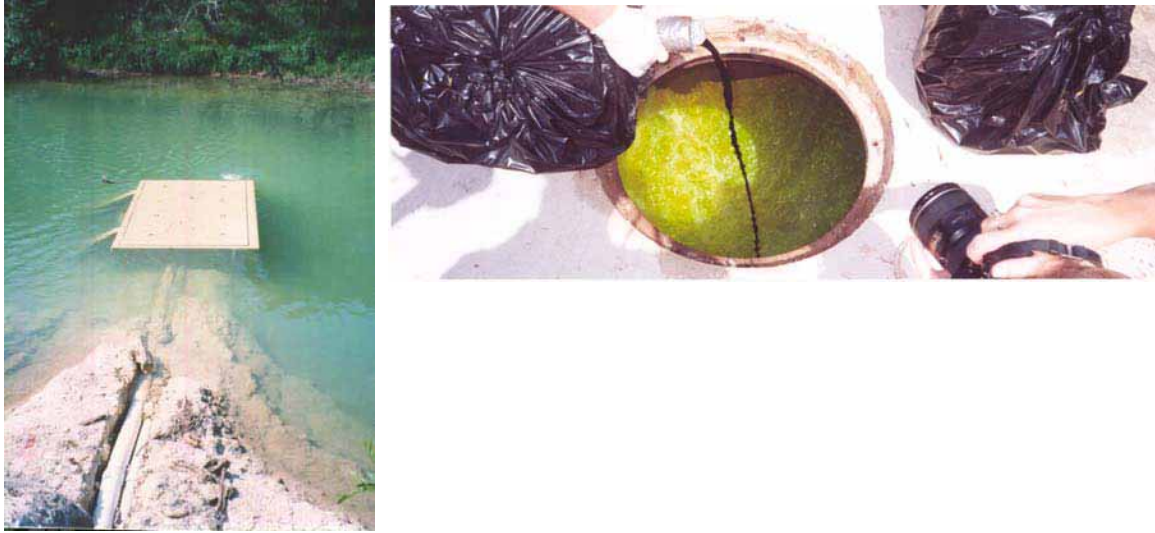
Figure 2. Concrete vault and valve system above Antioch Cave within Onion Creek (left). Sodium fluorescein dye being poured into the top of the vault (right).

Twenty-five pounds of sodium fluorescein were injected into Antioch Cave on August 2, 2002. Dye was injected by pouring the dye mixture directly into the top of the vault while the side valve was open, allowing recharge into the structure and cave (Figure 2). Thirty-five pounds of eosine were injected into Cripple Crawfish Cave on August 6, 2002. The District and the City of Austin injected dye into Cripple Crawfish Cave through a PVC pipe inserted into the feature from the bank (Figure 3).

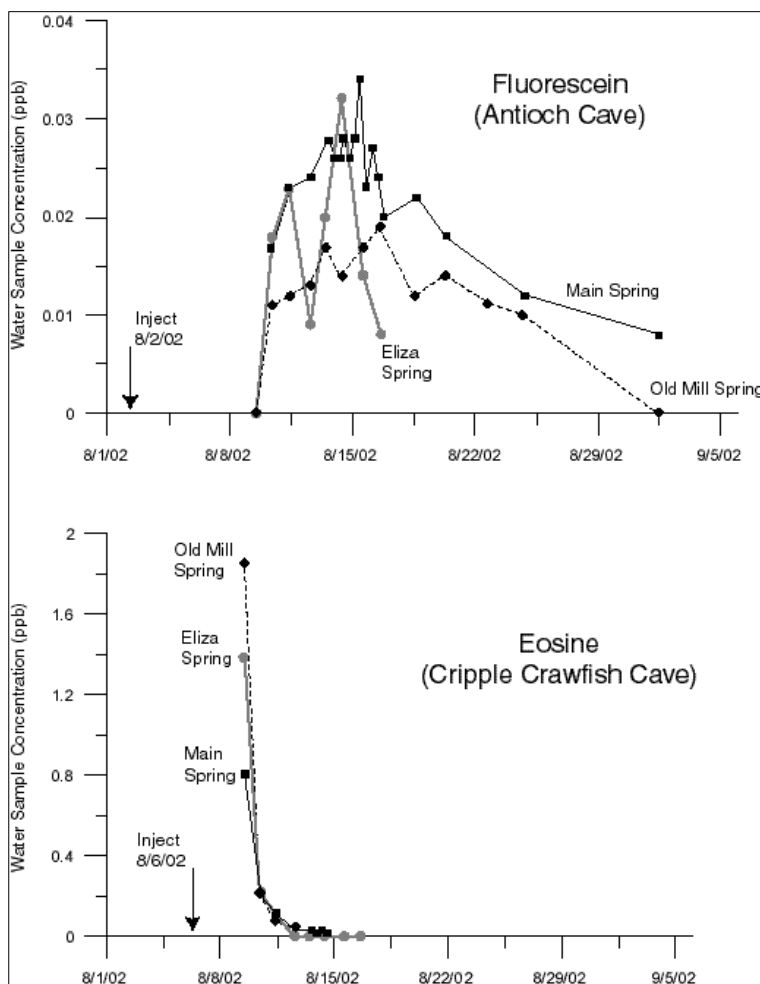
Figure 7. Breakthrough curves of sodium fluorescein and eosine at Barton Springs.

Breakthrough curves were prepared from the laboratory results, from which the initial travel time, duration, and peak concentrations were calculated. Breakthrough curves, which are graphs displaying dye concentrations over time, were evaluated to characterize the dye response at the springs (Figure 7).

Breakthrough concentrations peak soon after initial arrival, suggesting an aquifer system strongly influenced by conduit (rapid, pipe-like) flow rather than diffuse (slow) flow. Several sodium fluorescein breakthrough peaks on Figure 7 suggest arrival of dye via different (conduit) pathways.
